Hydromorphological changes on multiple scales in River Skjern

Published in:
Ecological Engineering

10 years after the largest river restoration project in Northern Europe: Hydromorphological changes on multiple scales in River Skjern

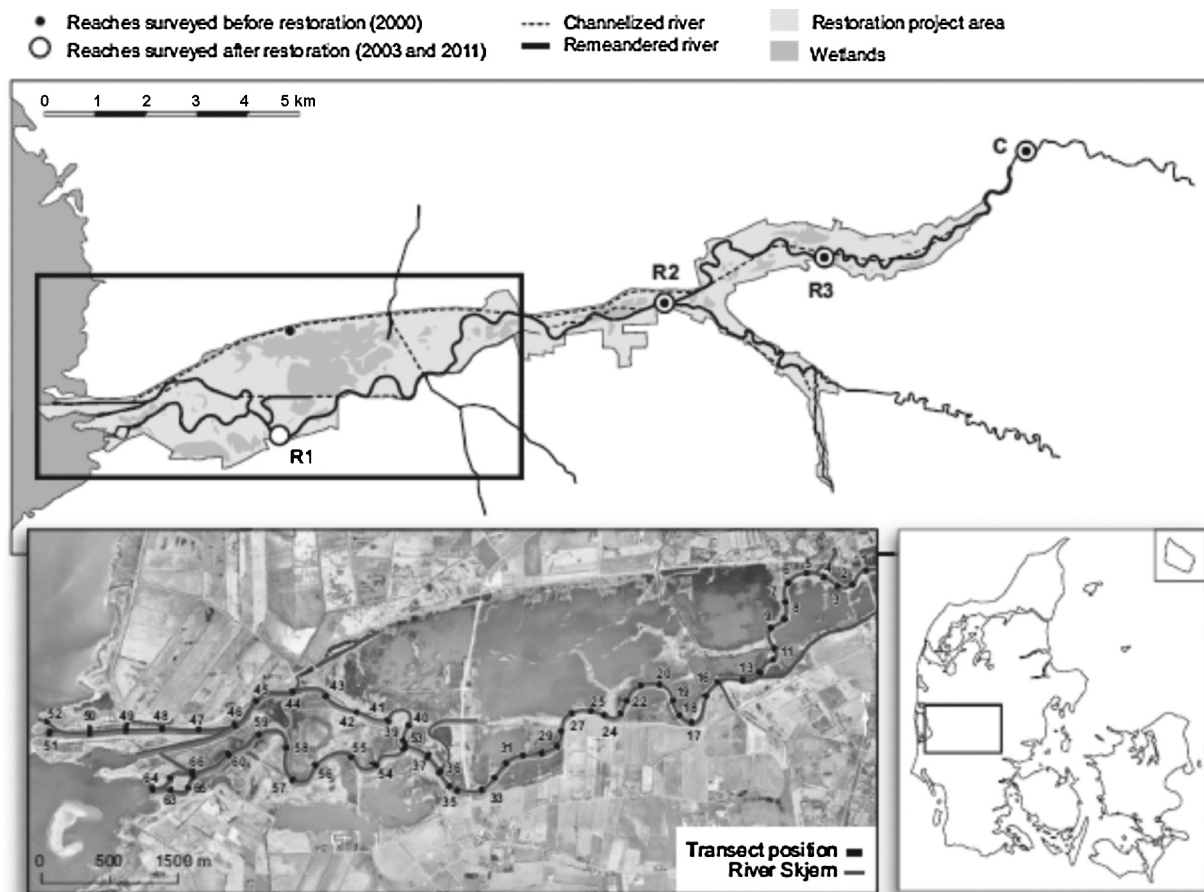
Fig. 1. Map showing the study area, study sites for in-stream habitats (R1, R2, R3 and C), and the position of transects used to measure channel stability (1–66).

the restored River Skjern (R1, R2, R3, Fig. 1) based on a comparison with a 300 m long control reach (C, Fig. 1) located upstream of the restoration area (Pedersen et al., 2007b). All four reaches were sampled once before the restoration (2000) and again immediately after the restoration (2003; Pedersen et al., 2007b). After the restoration the location of R2, R3 and C remained at the same location as pre-restoration, while, as a results of the restoration and filling-up of major parts of the channelized river, reach R1 was in 2003 moved from the northern drainage channel to the newly excavated river channel located app. 2 km south (Fig. 1). For this study, we re-sampled these four reaches in 2011 providing data for a long-term evaluation (app. 10 years) of the restoration on in-stream habitats. Identical surveying methods were used in all three years to allow for cross-year comparison, for a detailed description of the methodology, see Pedersen et al. (2007b). In brief, six transects were placed equally spaced along each of the four reaches and each transect was divided into 1 m × 1 m quadrats across the entire width. A GPS was used to exactly identify location of each transect. At each quadrat, depth (to nearest cm), current velocity (at 10 cm above the stream bed), dominating substrates (using seven categories according to the Wentworth-scale (Wentworth, 1922) and macrophyte coverage (%) was recorded. Recording of in-stream variables was done in September 2000, August 2003 and September 2011 and it was aimed to collect data at similar discharge levels. However, the summer 2003 was drier than normal and mean monthly discharge for August 2003 was 12.7 m³/s, while mean monthly discharge for September 2000 and September 2011 was 19.4 m³/s and 19.1 m³/s, respectively.

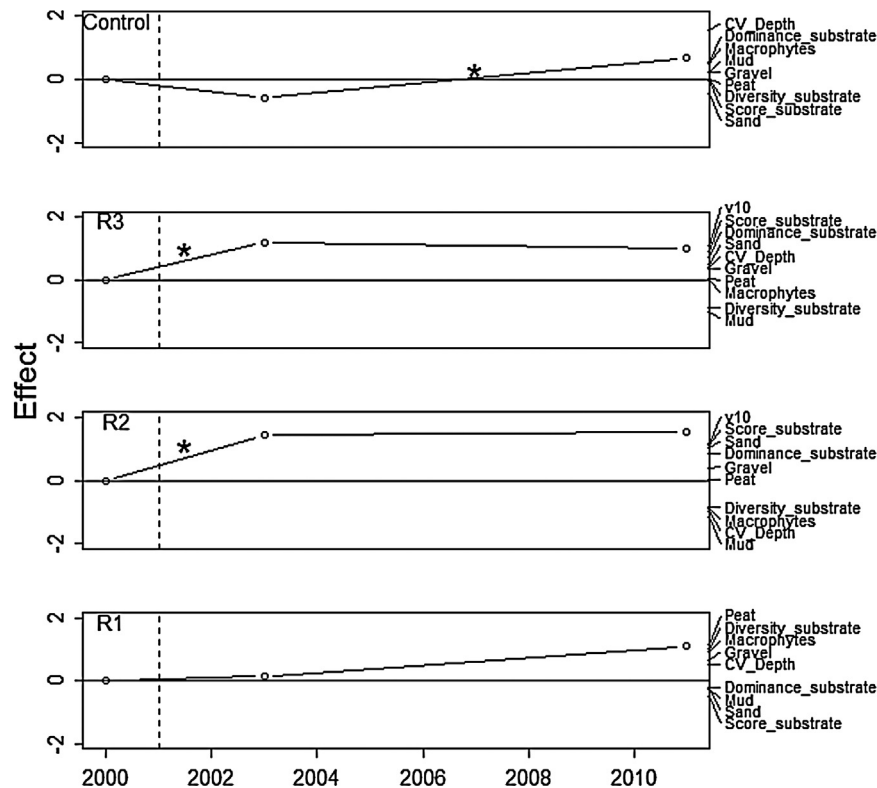
Fig. 2. Principal response curve analyses of the development of in-stream habitat parameters in four different sites of the vegetated zone (depths 0–130 cm) of River Skjern: control upstream the restored reaches (R1, R2, R3).

When comparing RDA scores, we found no significant overall change to in-stream habitats in the vegetated zone of the control reach from 2000 to 2003 ($P=0.493$; Fig. 2) however, from 2003 to 2011 there was a significant change ($P=0.0008$; Fig. 2). This change was primarily caused by an increase in CV Depth, indicating more heterogeneous stream profiles with larger variation in depth in

2011 compared to 2003. In the vegetated zone of R3 and R2 the restoration resulted in a significant change to in-stream habitats ($P=0.022$ and $P=0.026$, respectively). In this zone of R3, the restoration resulted in higher current velocities (v10), a coarser substrate (Score_substrate) although still dominated by sand, a higher coverage of gravel, a reduction in coverage by mud and consequently a lower substrate diversity (Fig. 2). In the vegetated zone of R2, the restoration also resulted in increased current velocities (v10), a coarser substrate (Score_substrate) although still dominated by sand, a relatively higher coverage of gravel, lower coverage of mud and a lower substrate diversity (Fig. 2). In addition, the analysis showed that the overall significant changes to in-stream habitats of the vegetated zone of R3 were also related to a reduction in macrophyte coverage (Fig. 2).

The observed changes to in-stream habitats in the vegetated zone of R3 and R2 were stable over time showing no change from 2003 to 2011 ($P=0.906$ and $P=0.722$; Fig. 2). The in-stream habitats of the vegetated zone in the most downstream reach (R1) was not significantly affected by the restoration as only very small changes occurred from 2000 to 2003 (Fig. 2). From 2003 to 2011 there was some development in in-stream habitats but these changes were not significant ($P=0.897$; Fig. 2).

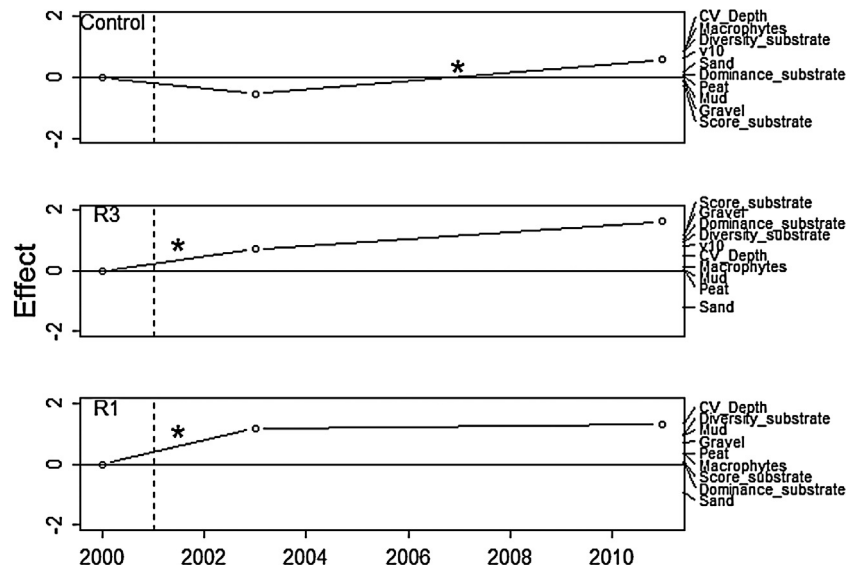
Fig. 3. Principal response curve analyses of the development of in-stream habitat parameters in four different sites of the current zone (depths >130 cm) of River Skjern: control upstream the restored reaches (R1, R2, R3).

Similar to the vegetated zone, we found no significant overall change to in-stream habitats in the main current zone of the control reach from 2000 to 2003 ($P=0.460$; Fig. 3) and a small but significant change from 2003 to 2011 ($P=0.011$; Fig. 3). This change was primarily driven by an increase in CV depth, macrophyte coverage and substrate diversity over the period (Fig. 3). In the main current zone of R3 and R1, the restoration resulted in a significant change to in-stream habitats ($P=0.02$ and $P=0.011$ respectively; Fig. 3), primarily caused by a higher variation in depth (CV depth) and higher coverage by gravel and consequently a higher substrate score, a higher substrate dominance score and a higher substrate diversity (Fig. 3). As found for the vegetated zone of R3 and R1, the observed changes to in-stream habitats following restoration, stayed stable over time in the main current zone of R3 and R1 ($P=0.161$ and $P=0.897$, respectively; Fig. 3). No analysis was performed for R2 for the main current zone as only very few quadrates had depths over 130 cm.

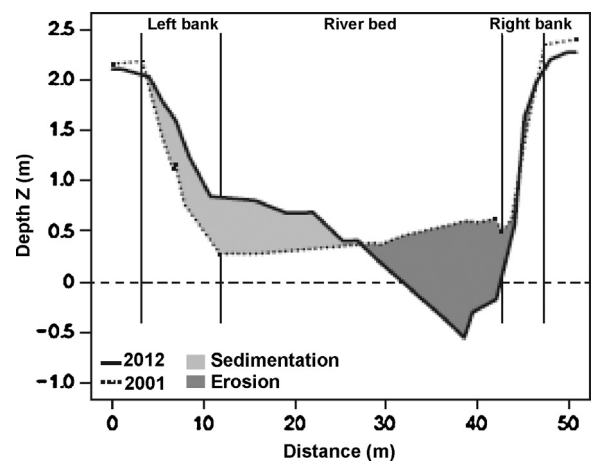
Fig. 4. Example of cross-sectional adjustments of the River Skjern between 2001 and 2012.

The survey of 65 cross-sectional transects along the lower 10 km of River Skjern in 2001 and again in 2011 revealed marked morphological adjustments through erosion and sedimentation in the newly restored stream channel (Fig. 4). There was large variations in the morphological adjustments among transects during the 10 year period (Fig. 5). Average sedimentation and erosion volume (\pm SD) measured at the left bank amounted to $231 \pm 360 \text{ m}^3$ and $274 \pm 325 \text{ m}^3$, respectively, resulting in a net erosion of 43 m^3 sediment. For the right bank, average sedimentation and erosion volume (\pm SD) was $192 \pm 340 \text{ m}^3$ and $536 \pm 740 \text{ m}^3$, respectively, yielding a net erosion of 344 m^3 sediment. However, the most pronounced morphological changes were observed at the river bed. Average sedimentation (\pm SD) for this part of the cross-sectional transects was $2259 \pm 2333 \text{ m}^3$ sediment and average erosion (\pm SD) was $707 \pm 996 \text{ m}^3$ resulting in a net sedimentation of 1552 m^3 sediment. Combined, the net balance resulted in a gain of 1166 m^3 .

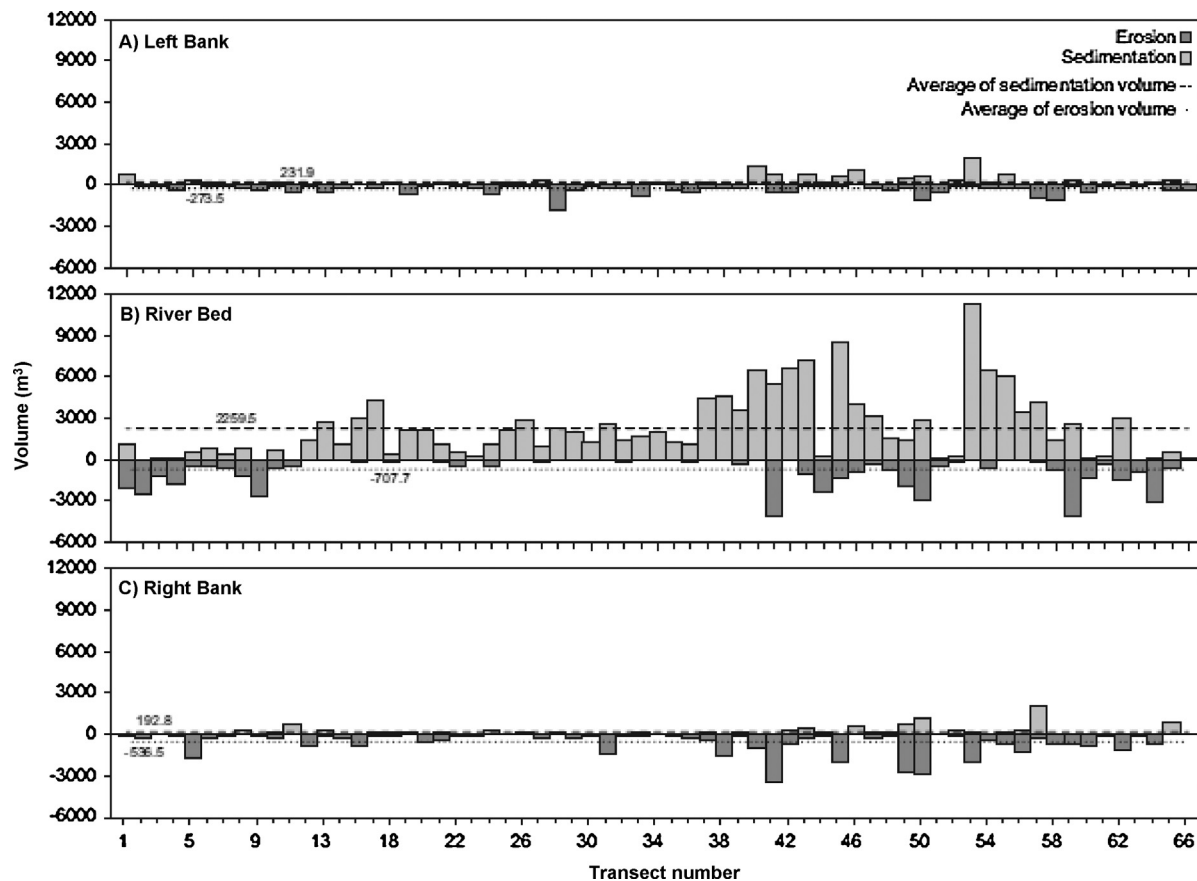
Fig. 5. Erosion and sedimentation in the lower 10 km of the restored River Skjern over a 10 year period (2001–2011).

sediment over the 10 years in the restored river channel. The net result is a slightly wider and shallower river in 2011 than in 2001.

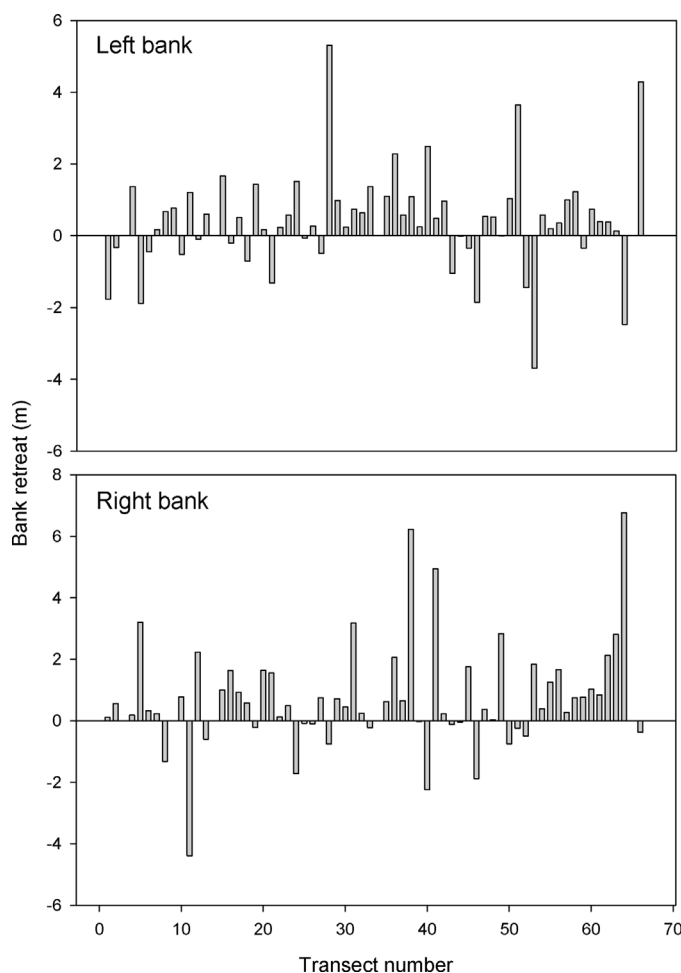
Fig. 6. Bank retreat in the lower 10 km of the restored River Skjern over a 10 year period.

There was large variation in bank retreat among transects (Fig. 6) and average bank retreat for left banks was 39 cm and 68 cm for right banks. This corresponds to a forecasted bank retreat of 3.9 m for left banks and 6.8 m for right banks over a 100 years period.
